Comparative tests between products with UV powder paint and products with standard powder paint

1 PURPOSE

In the **first part** will be verified the different characteristics in terms of mechanical resistance and the different properties between a standard polyester painting and a crosslinking painting induced by UV irradiation, applied on steel sheets.

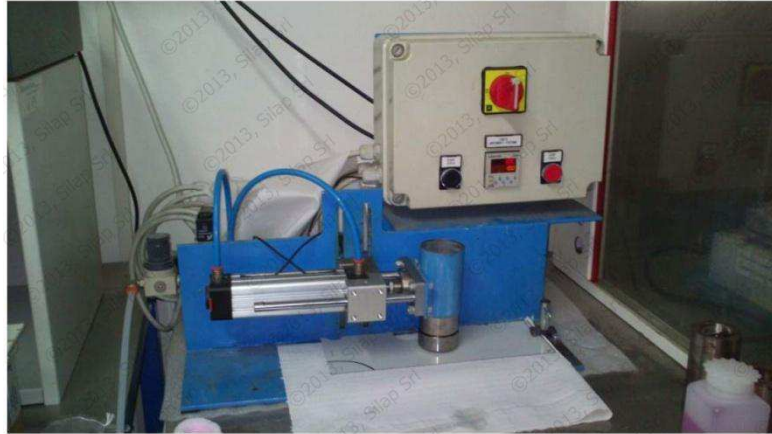
The test was performed by subjecting the samples to continuous passages of a swab soaked in solvent maintained in contact with the surface by a mass of 1 kg.

Picture 3 - Equipment for solvents test

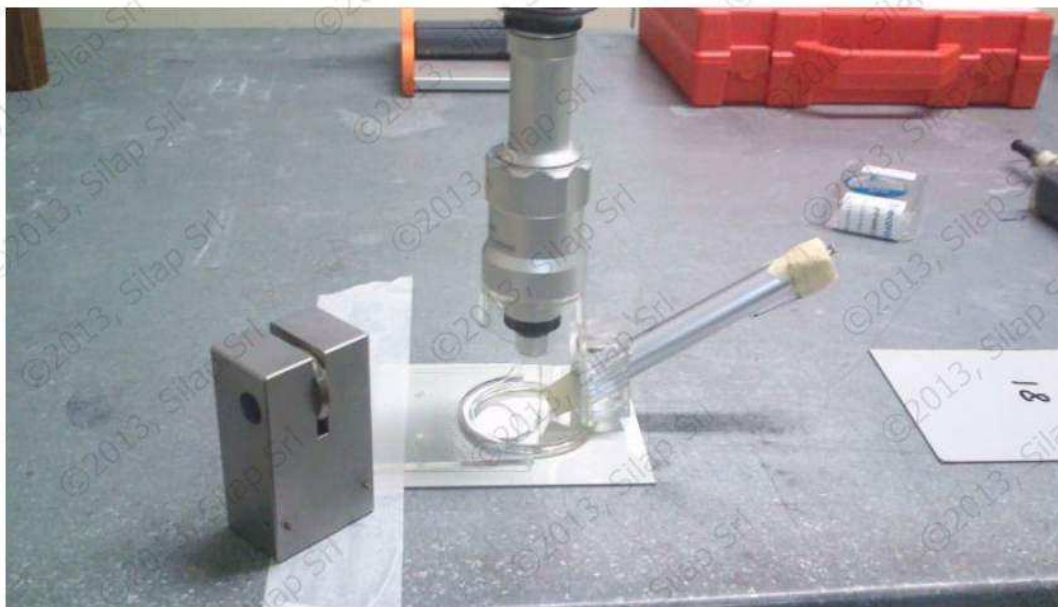
The test was performed according to ISO 2815. Both samples gave the same value as hardness index, equal to 111.

Picture 5 – Buchholz hardness test machine

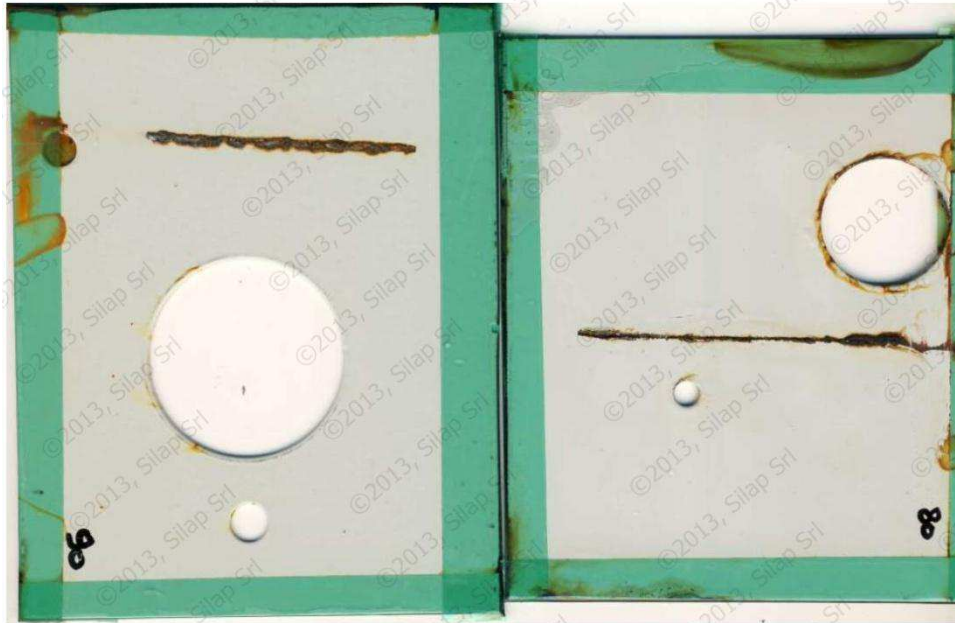
RESULT OF NEUTRAL SALT SPRAY FOG TEST AFTER 200 HOURS

The samples were tested for a total of 400 hours and were monitored periodically throughout the duration of the test.

Picture 6 - result of neutral salt spray fog test after 200 hours; on the left the sample B, on the right the sample A

The sample A has some slight blistering principle that the B sample coated with UV paint hasn't.

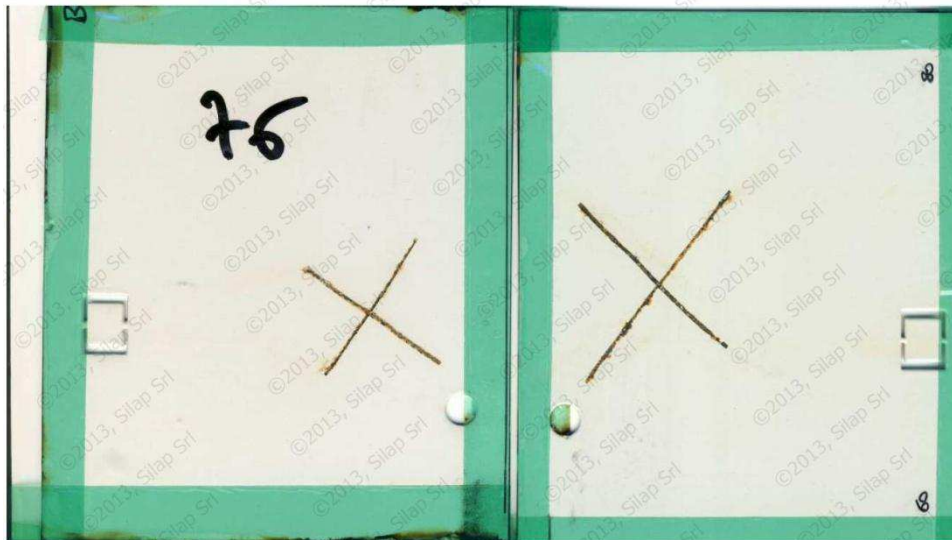
RESULT OF CONDITIONING MOISTURE TEST AFTER 200 HOURS

Picture 7 - result of conditioning moisture test after 200 hours; on the left the sample B, on the right the sample A

- From the results gathered it can be seen as both samples exhibit a high degree of moisture resistance.
- In the non-engraved area doesn't appear defects in any of the 2 samples.
- Near the incision, both samples show the formation of bubbles (blistering).
- On the SAMPLE B there are many bubbles having a diameter of about 2 mm; On the SAMPLE A there are fewer than the SAMPLE B but any of these has a diameter of about 5 mm.
- We observe very little rust limited to the incision, which exposes the substrate.
